Fatigue Behavior of Bolted Joints in RR58 Aluminium Alloy with and without Interfay Sealant

F. E. Kiddle

Structures Dept., R.A.E., Farnborough Hants.

February 1976

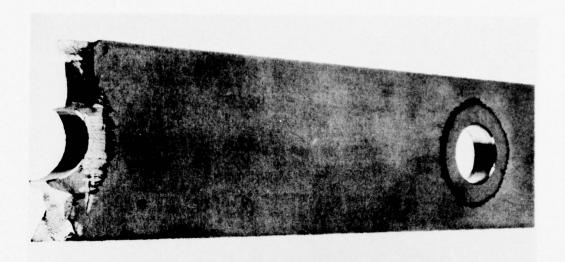
Fig.4 Typical fractures on RAE joint specimens

Specimens were tested until failure or to 10⁷ cycles. Whereas all HSA joints failed through the net cross section, cracks being primarily initiated by fretting between bolt and lug hole, RAE joints failed through the gross section by cracks initiated at many points over a circular arc of fretting damage at the boundary of the clamping area (see examples of centreplate failures illustrated in Fig.4).

The modes of failure in the two types of joints were described in section 3; all RAE joints failed through the gross section (see Fig.4), and all HSA joints through the net cross section. In the RAE joint, fatigue cracks nucleated in the centreplate at many points over a circular arc of fretting damage corresponding to the boundary of the clamping area. When the RAE joints were dismantled after failure, the bore of the lug showed no signs of bearing or fretting and it is deduced that virtually the whole of the applied load was transmitted by friction between the sideplates and centreplate. By contrast failure of the HSA joint through the hole indicates that a proportion of the applied load was transmitted via the bolt in the lug hole. Presumably at the high load amplitudes the flexibility of the interfay allowed significant bearing of the bolt in the hole and at the low load amplitudes although the proportion of load transmitted in this way was much smaller, failure at the gross section was effectively prevented by the action of the interfay compound in suppressing fretting between the faces of the joint.

a. Joint (failure through hole)

b. Joint (failure away from hole)

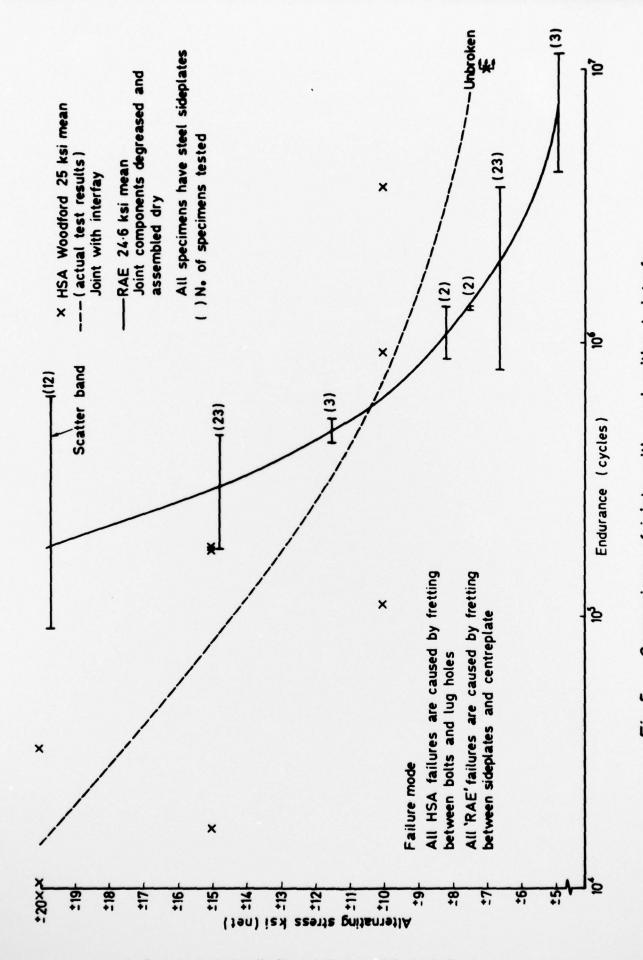
Fig. 5 Comparison of joints with and without interfay

Fig. 5 presents mean S-N curves for the two joints. In the case of the HSA joint individual test results have been plotted whereas for the RAE joint, because of the large number of tests, scatter bands are indicated which include all results at each stress level. It is seen from Fig. 5 that the effect of including interfay in a joint is to reduce fatigue endurance by a factor of about 10 at the highest stress level studied but tends to improve endurance at low alternating stress levels.

From the above discussion it is concluded that the effect on endurance of introducing a flexible sealant between the faces of a bolted joint is to decrease life significantly at high stress levels by encouraging the transfer of load via the bolt in the hole where stress concentration is high, but to increase life at low stress levels and raise the fatigue limit by suppressing fretting between the faces of the joint.
